**Attachment 5**  
**Eola Main Line Improvements Aquatic/Stream Impact Analysis**  
**Conceptual Mitigation Technical Memorandum**

## Chicago to Iowa City Intercity Passenger Rail Service - Eola Main Line Improvements Aquatic/Stream Impact Analysis and Conceptual Mitigation Plan

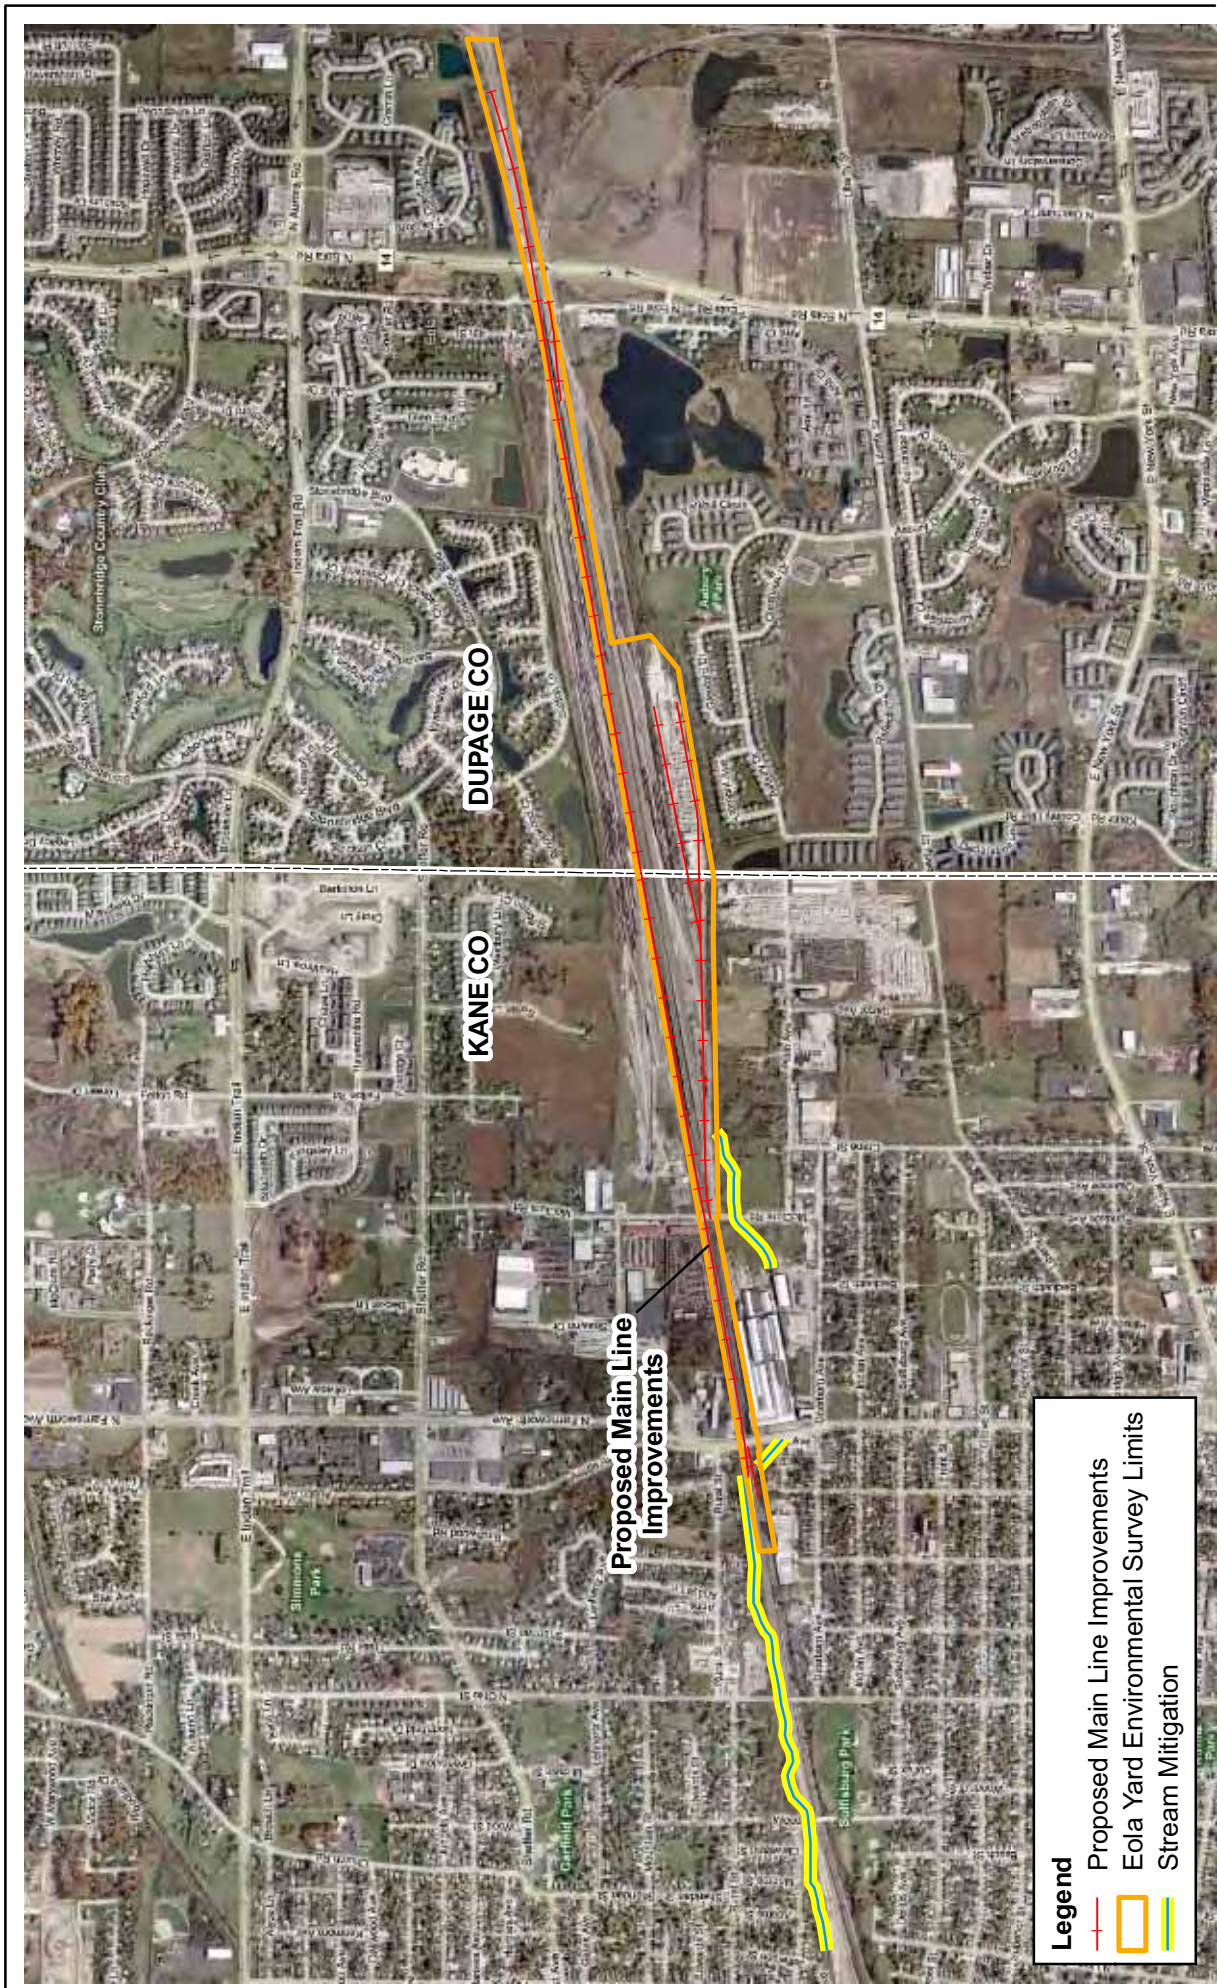
**FIGURE**  
3

# Off-Site Stream Mitigation

Approximately 6,500 linear feet of aquatic habitat along Indian Creek (Figure 3) could be enhanced through a combination of exotic species removal, wetland plantings, bank stabilization, and/or installation of the appropriate in-stream treatments such as: cross veins, j-hooks, porous weirs, newberry riffles, or root wads (Attachment C). Exact locations for the downstream mitigation measures have not been selected at this point of the project; however, detailed surveys to identify specific mitigation sites will be conducted during the Tier 2 project level NEPA environmental assessment process. These structures will be strategically located throughout Indian Creek to optimize their effect on scour and deposition along the creek. Installation of channel treatments will enhance stream substrate and aid in the development of riffle-pool sequencing to restore a more natural width to depth ratio.

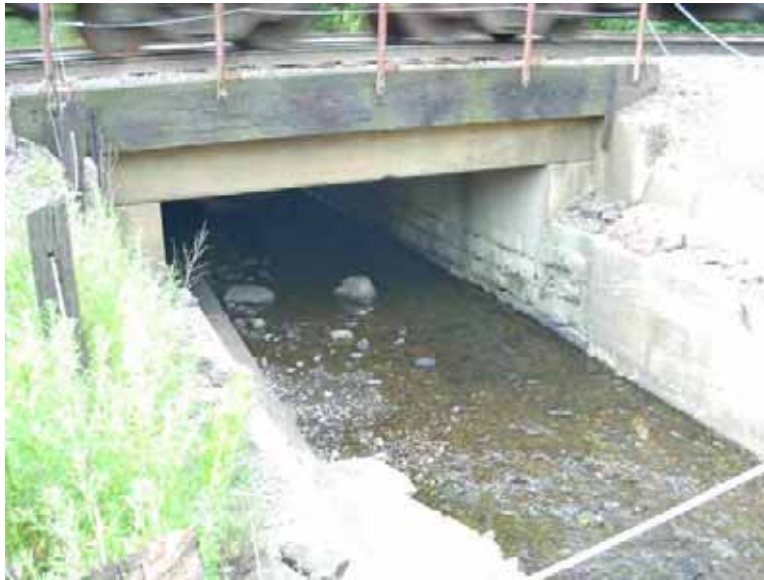
Looking at double box culvert that contains flow of Indian Creek, at the west end of the Eola yard, west of Farnsworth Ave.

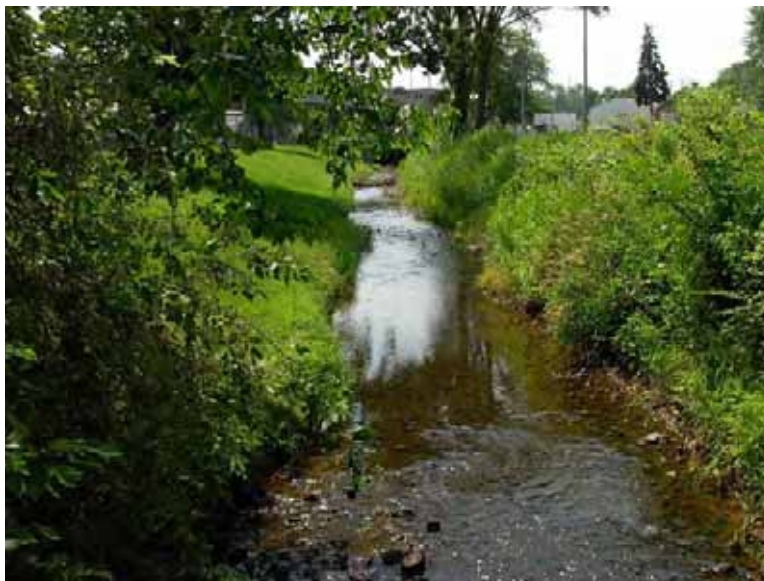
Looking south at Indian Creek channel flowing north within the west end of the Eola Yard, west of Farnsworth Avenue

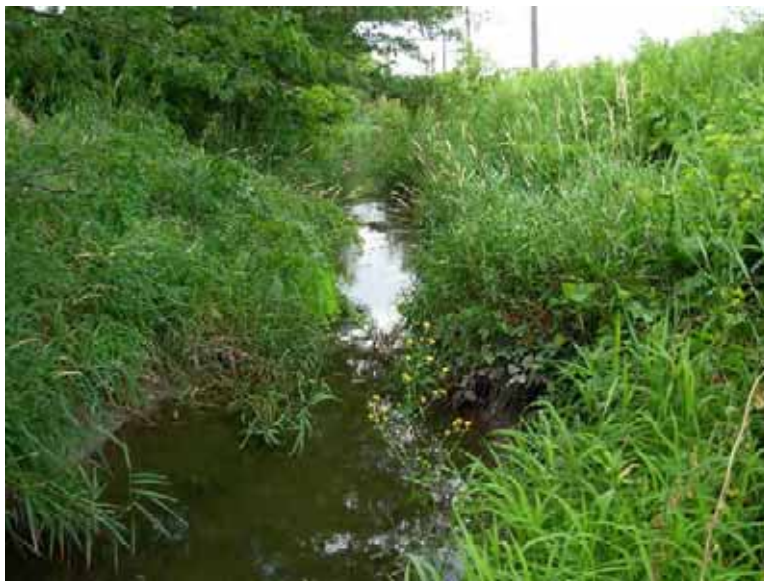
Looking east at the section of natural stream channel within the Eola yard that would be impacted by the new tracks

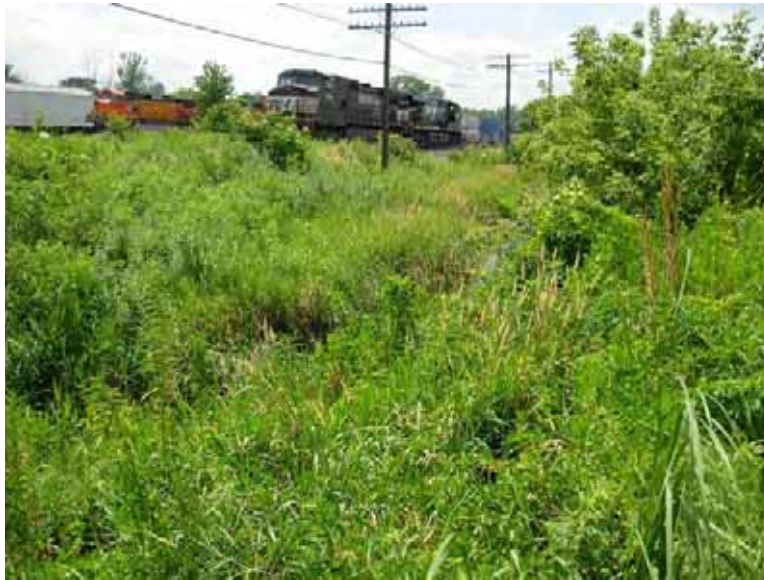
Looking west from the top of the embankment at the natural stream channel and adjacent riparian vegetation

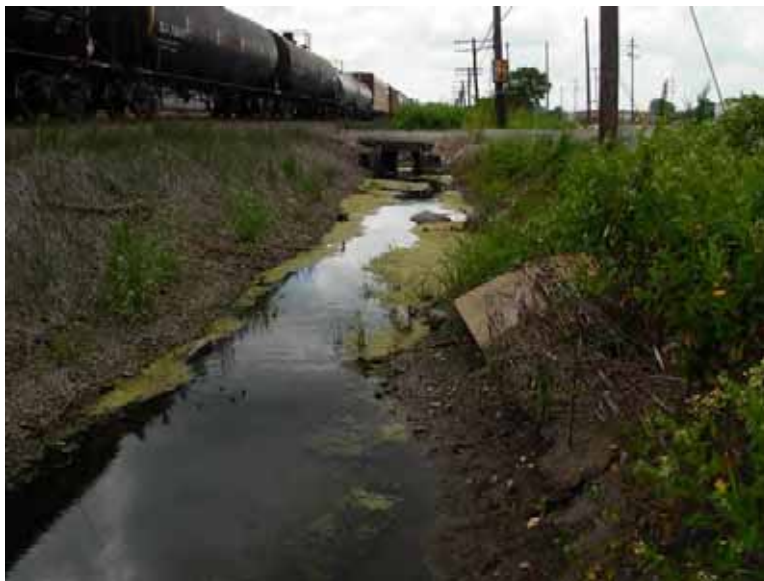
Looking east at the linear drainage feature as it loses its riparian vegetation and becomes more of a wet bottom storm water conveyance

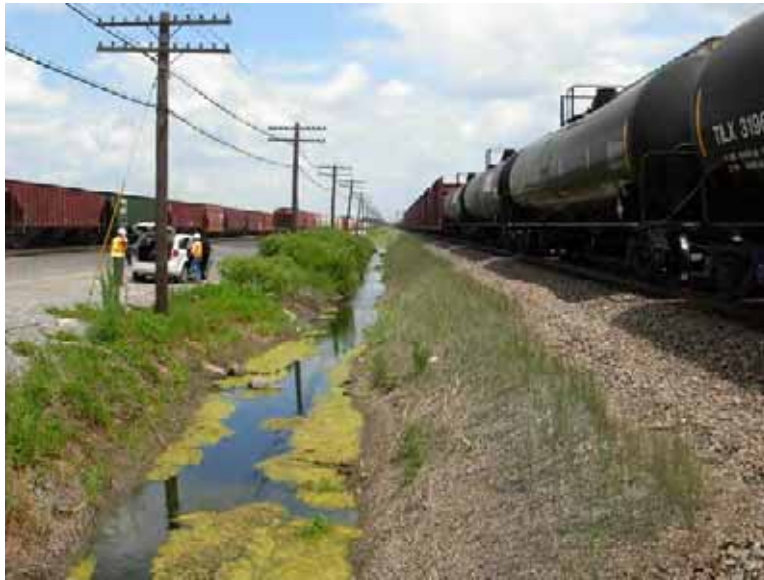
Looking east at the drainage feature as it loses flow, notice the large patches of filamentous algae

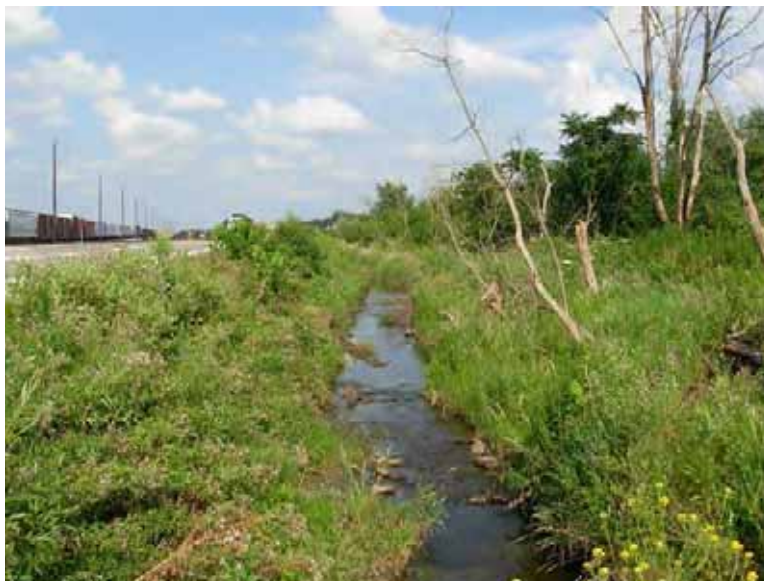
Looking east at the stream channel of Indian Creek along the southern boundary of the Project area
