Attachment 6
Wyanet Connection Aquatic/Stream Impact analysis
Conceptual Mitigation Technical Memorandum

Chicago to Iowa City Intercity Passenger Rail Service - Wyanet Connection Aquatic/Stream Impact Analysis and Conceptual Mitigation Plan

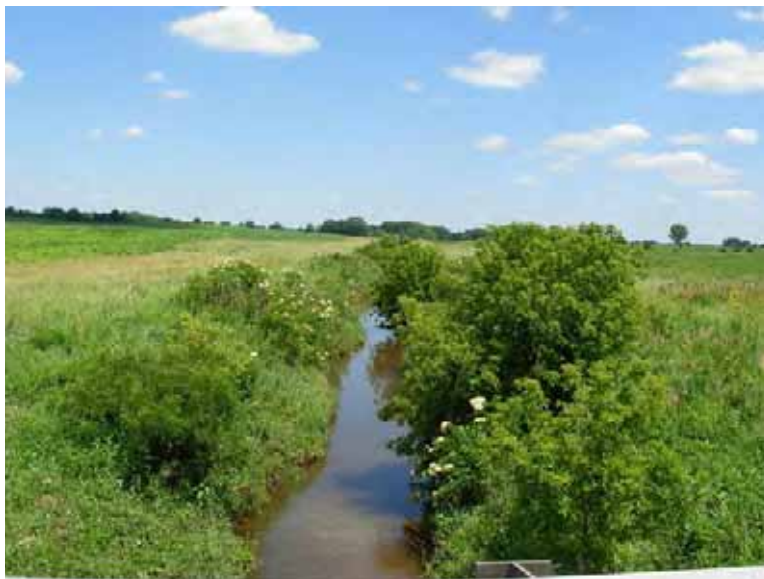
2. Looking East at the trapezoidal channel of Pond Creek from 1200 East Bridge

Within the Wyonet Connection section of the Project area, Pond Creek is located at the base of a large trapezoidal-shaped channel, approximately 15 to 20 feet below top of bank. The stream has been heavily incised, straightened, confined, and isolated from the majority of its riparian floodplain; however, the channel does maintain a riparian wetland bench approximately 50 to 75 feet wide. The bench is approximately 1 to 2 feet above the wetted channel under normal base flow and appears to be frequently inundated as flood waters increase after rain events. The bank's slopes are approximately 1.5:1 (H:V) from the toe of the bench to the top of the bank. The slopes are very steep; however, they appeared stable and were well vegetated from the edge of the water to the top of the bank.

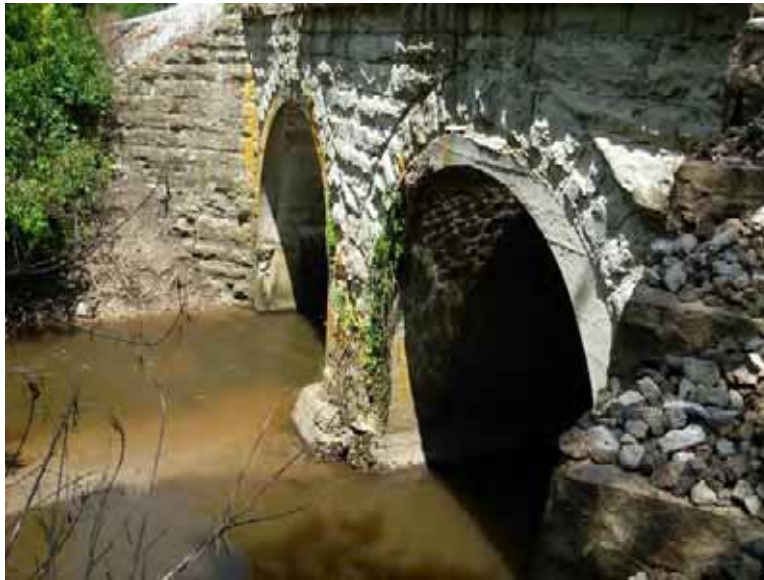
5. Looking west at the double arched culverts open bottom culverts within the IAIS rail embankment

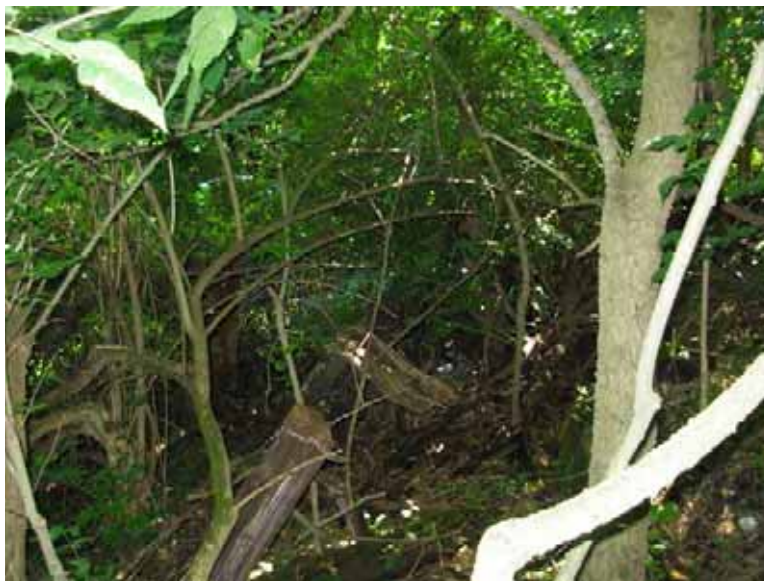
8. Honeysuckle invades the riparian slope adjacent to the rail embankment.

During the field survey conducted on June 30, 2010, observations of Pond Creek for the 15 habitat metrics were mostly within the fair to poor category, generating a total score of 74 out of 208. This score indicates that the habitat within the affected reach has not been able to fully recover from the impacts of channelization that occurred at the turn of the century. In general, the bank zone habitat and substrate habitat within the channelized reach of Pond Creek is very homogenous. This reach maintains little channel sinuosity and lacks typical riffle-pool sequencing in natural unaltered streams. The majority of the stream habitat within Pond Creek is similar in flow, depth, substrate, and velocity and can be characterized as a run or glide habitat. The riparian vegetation surrounding stream is a mix of both herbaceous and woody species. In some areas, bush honeysuckle has completely eliminated all other species within the

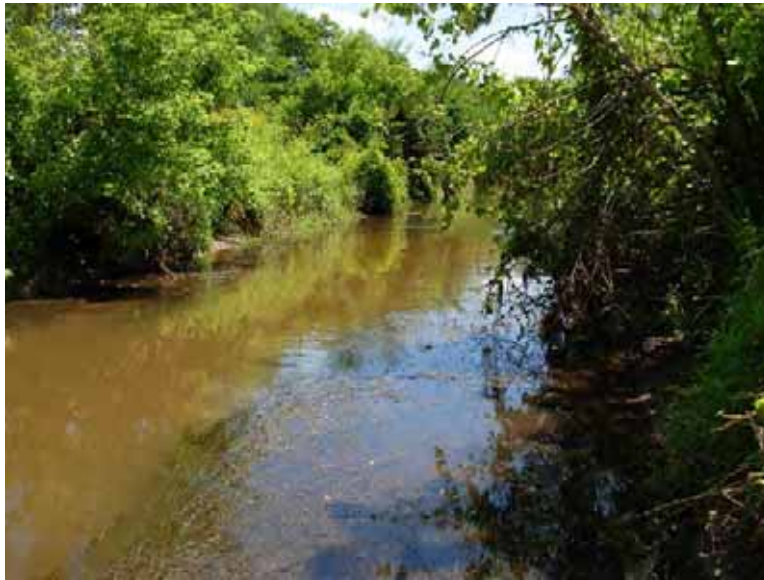
9. Looking downstream at a typical section of Pond Creek, notice the stable, well vegetated banks

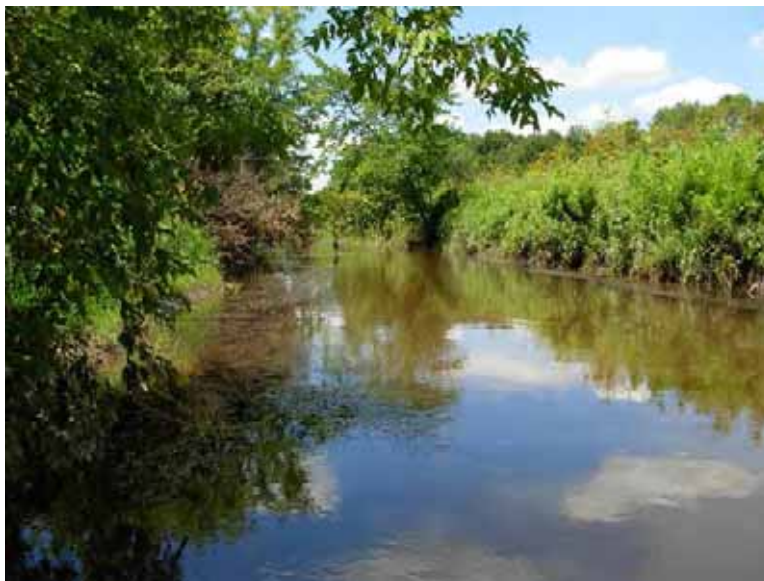
10. Looking west (upstream) at Pond Creek, notice submerged vegetation along the left bank of the stream.

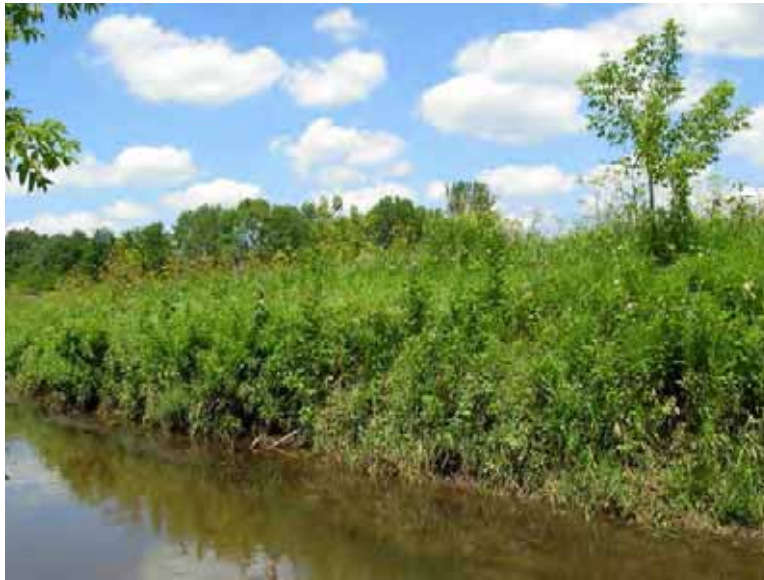
11. Looking at a typical slope along the north bank of Pond Creek, slopes of approximately 1.5:1

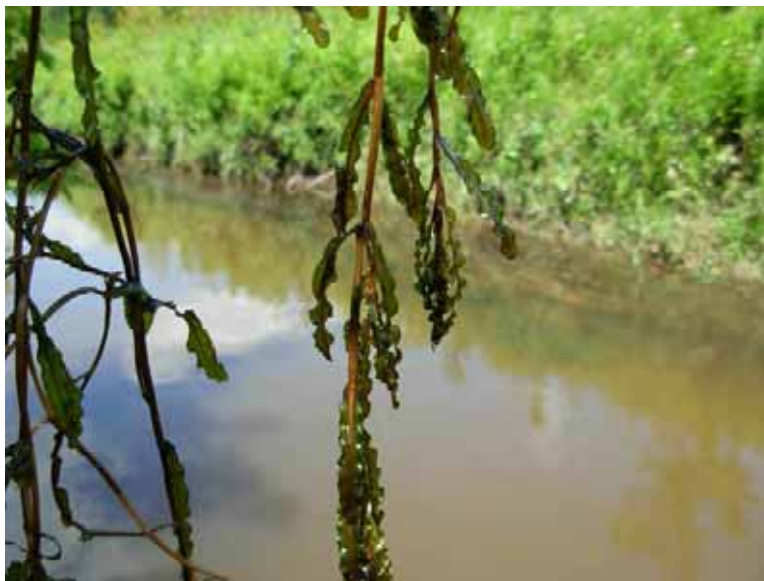
12. Curly leaf pond weed has successfully colonized a narrow zone along the bank where flows are not to strong

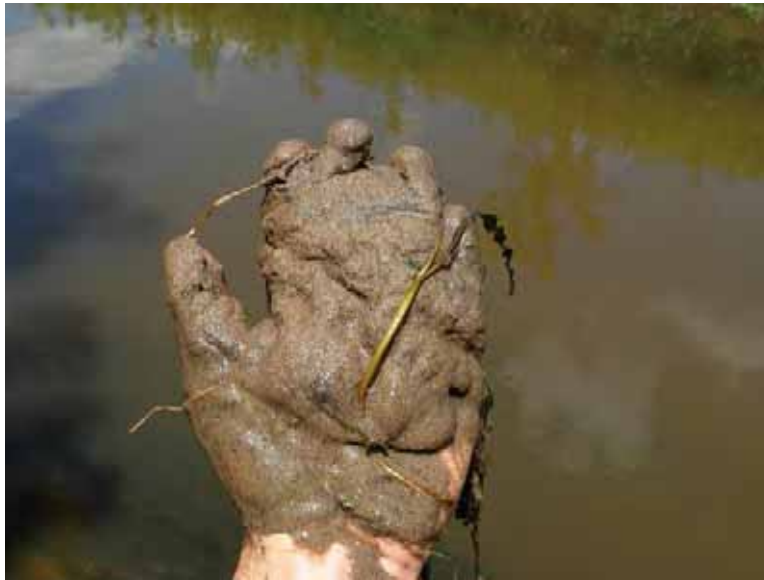
13. Typical fine grained sand substrate within the majority of the stream channel

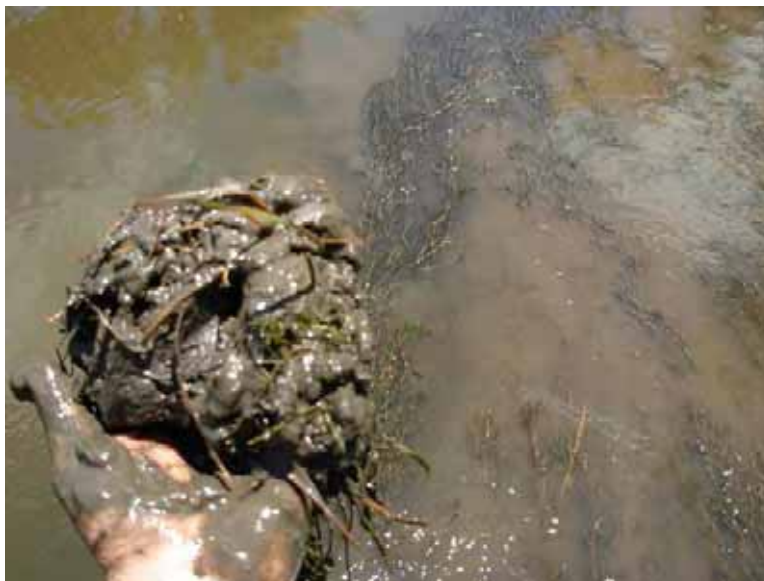
14. Typical silt substrate at the edge of the channel

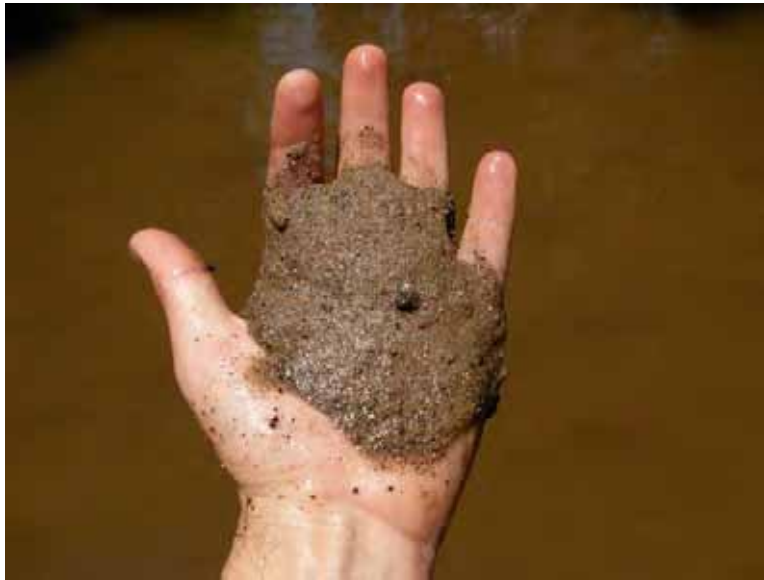
15. Typical coarse grained sand substrate within the some portions of the stream channel

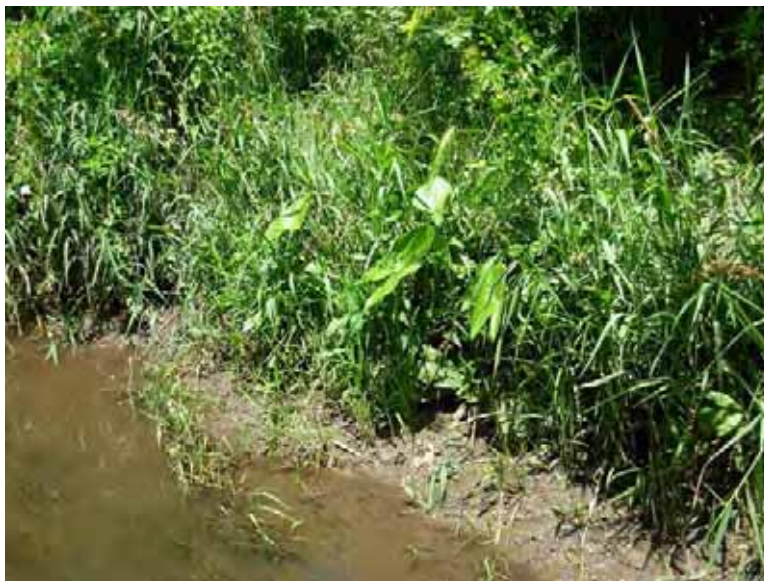
16. Typical emergent wetland fringe at the edge of the channel

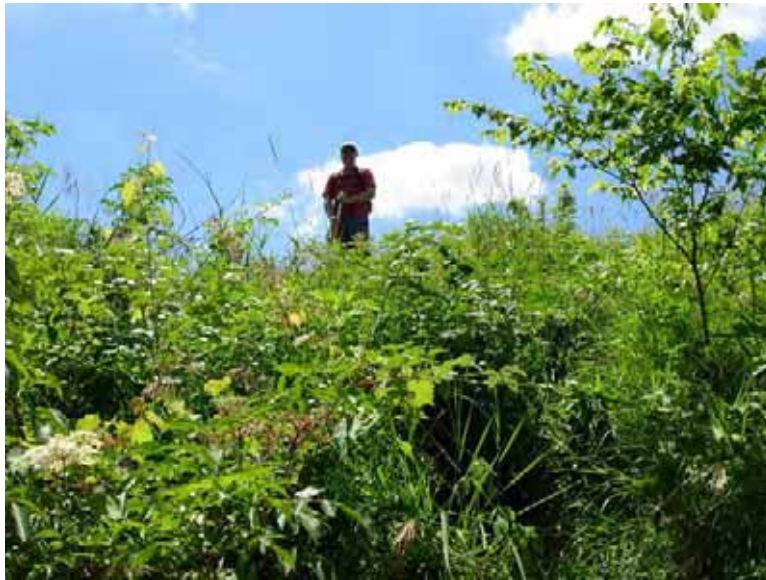
17. Looking from within Pond Creek at a typical bank height of 15-20 to the top of bank.

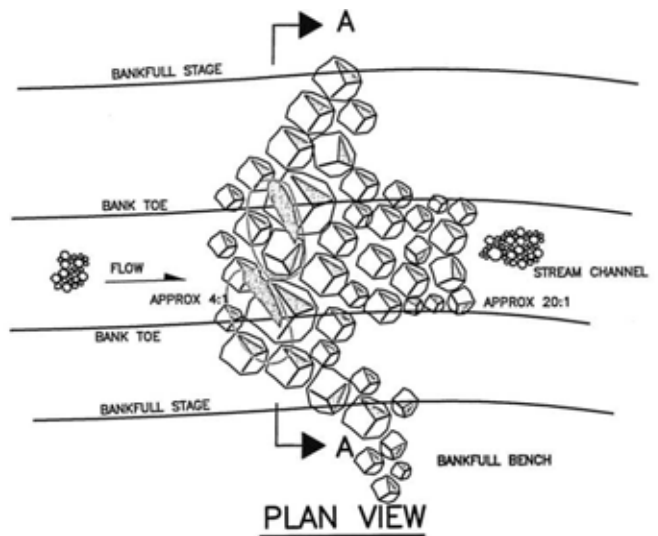
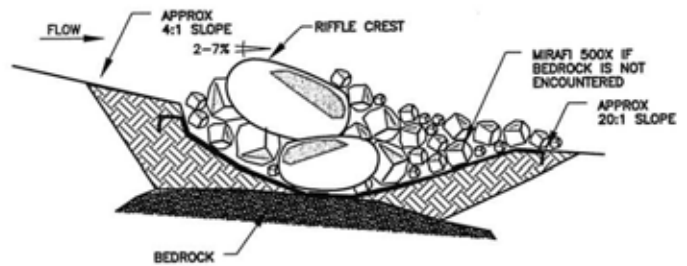
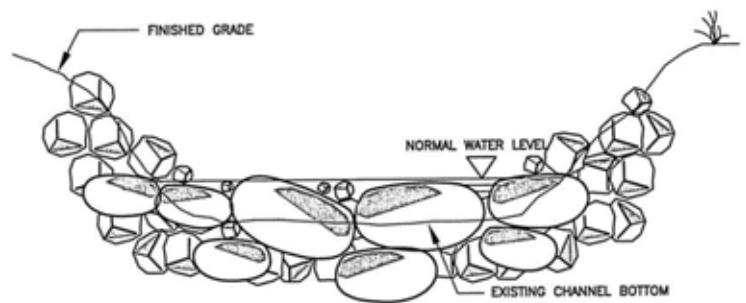
CONSTRUCTED BEDROCK RIFFLE

1. PLAN: BUILD RIFFLE TO EXTEND ACROSS BASE OF STREAM WITH LARGEST DIAMETER BOULDERS AT CREST LINE AND REDUCE SIZES PROGRESSIVELY DOWNSTREAM. CREST BOULDERS SIZED 1.5 TO 2 TIMES MAXIMUM SIZE TRANSPORTABLE WITH TOP-OF-BANK EVENT. RIFFLE CREST HAS SIMILAR SIZED FOOTERS TO COHESIVE SAPROLITE OR BEDROCK.

2. PROFILE: CONSTRUCT DOWNSTREAM FACE OF RIFFLE AT APPROXIMATELY 20:1 AND UPSTREAM FACE AT APPROXIMATELY 4:1 SLOPE. SLOPE SHOULD BE ADJUSTED TO MEET DESIGN RIFFLE:POOL RATIO, AND RIFFLE SLOPES.

3. CROSS SECTION: V-SHAPED CREST CUT DOWN TOWARDS CENTER OF CHANNEL.
4. SURFACE: SPACE LARGE SURFACE ROCKS 20 TO 30 CM APART ON THE DOWNSTREAM FACE OF THE RIFFLE TO FORM LOW FISH PASSAGE CHANNELS.

5. BANKS: EXTEND RIFFLE SIDE SLOPE UP BANK TO LEVELS EQUAL TO HEIGHT OF COIR FIBER LOGS, AND THEN EXTEND CREST BACK WITH ROCK PLACED WITHIN BANDS AT 20 TO 30° ANGLE FROM BANK, AND WITH RISE ANGLE OF 2-7° (AS SEEN IN THE CROSS VANE STRUCTURE).

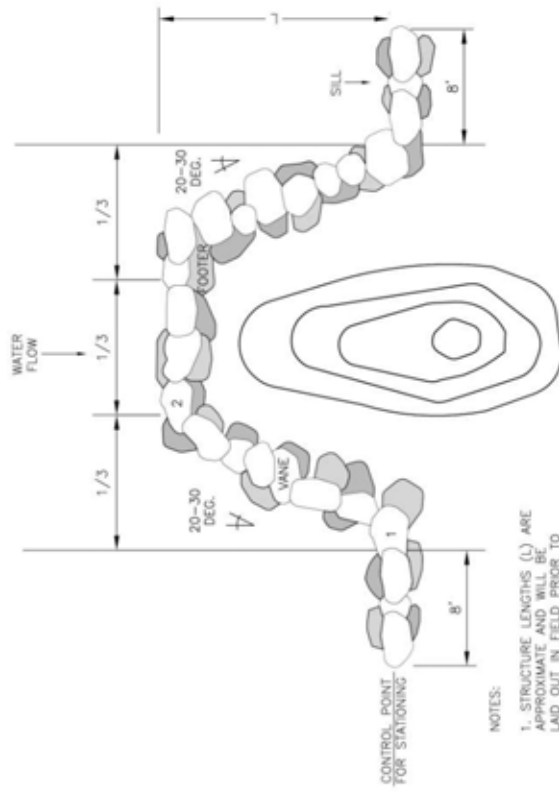
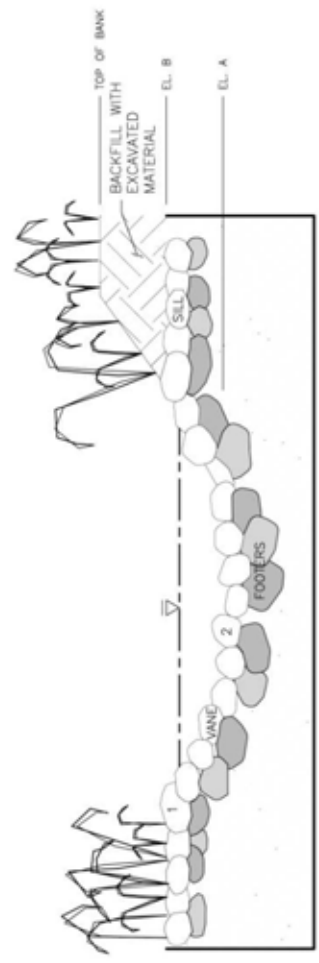
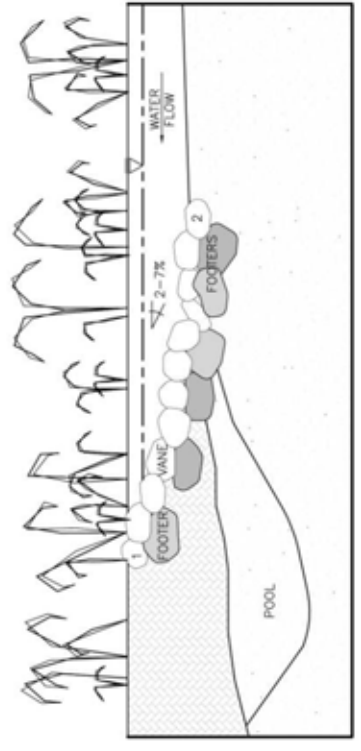
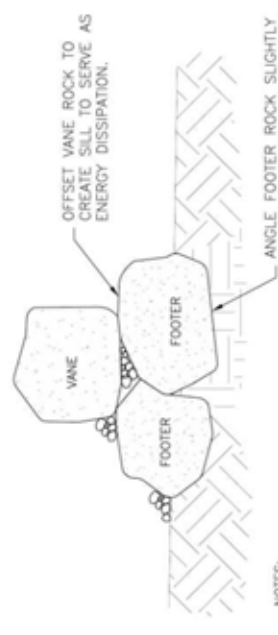
NOTES:
 1. STRUCTURE LENGTHS (L) ARE APPROXIMATE AND WILL BE LAID OUT IN FIELD PRIOR TO CONSTRUCTION

NOTES:
 1. GRAVEL BEDDING ALLOWING GOOD ROCK TO ROCK CONTACT.
 2. GOOD CONTACT BETWEEN VANE ROCKS AND FOOTER ROCK MUST BE MET TO ENSURE STABILITY.

OFFSET VANE ROCK TO CREATE SILL TO SERVE AS ENERGY DISSIPATION.

ANGLE FOOTER ROCK SLIGHTLY UPSTREAM TO ENSURE STABILITY OF VANE ROCKS.

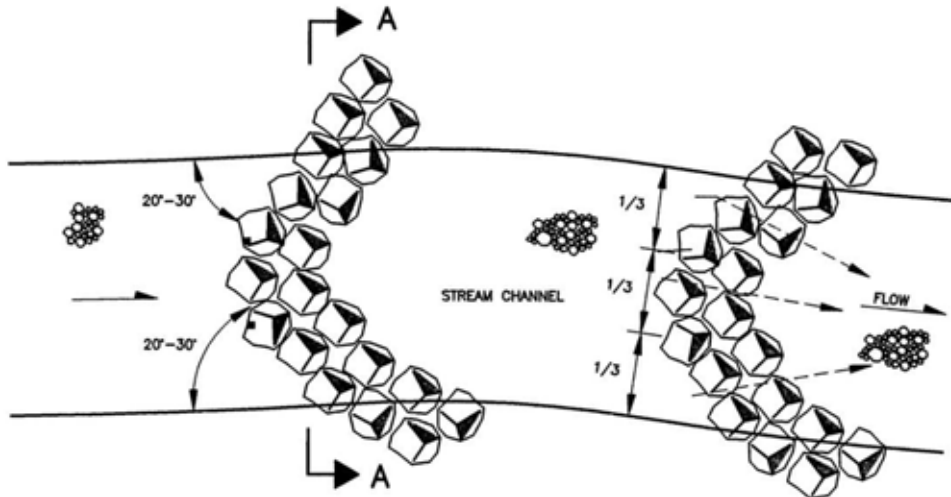
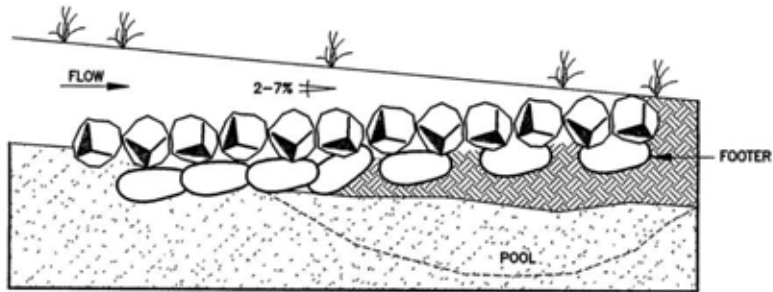
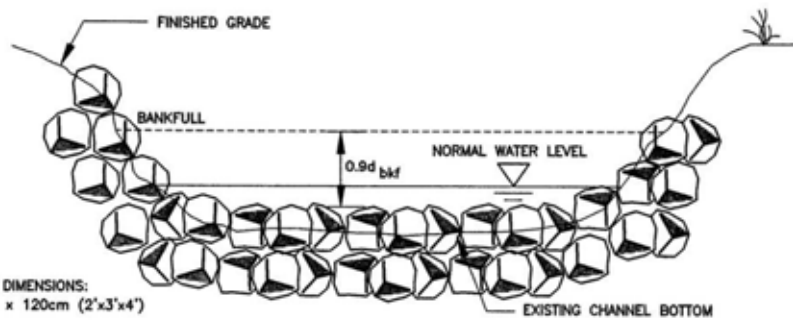
SECTION A-A
ROCK CROSS VANES
NO SCALE

MIN. BOULDER DIMENSIONS:
60cm x 90cm x 120cm (2'x3'x4')
BOULDER SPACING:
TO BE DETERMINED IN FIELD
